QA-196
Wharf House
Centreville
Private

INVENTORY FORM FOR STATE HISTORIC SITES SURVEY

Wharf House**2 LOCATION**

WHARF HOUSE
CENTREVILLE, MARYLAND

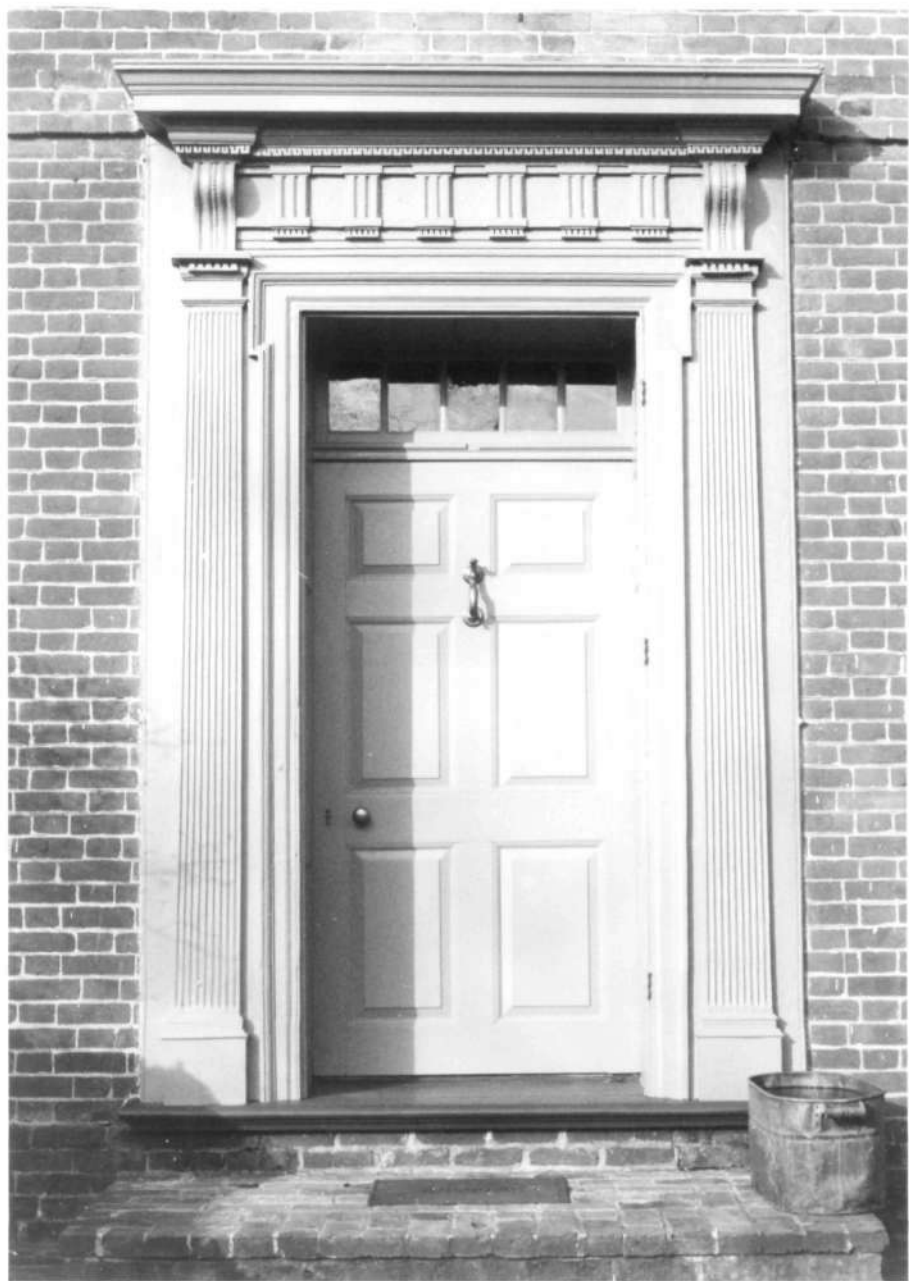
QH-196 Wharf House - Door
OR v 1978
Centerville Wharf

The northwest facade, facing Corsica Creek, is similar to the front facade. The brickwork, cornice, and fenestration are identical, but the window openings do not have decorative lintels and the original door surround is missing. A new door surround of very fine craftsmanship was made by the present owner, William Franklin. Decorative elements were based on the front door and the interior woodwork. The middle dormer on this facade is slightly larger than the flanking dormers, with a six-over-six window in the center, flanked by a pair of two-over-two sash.

To the right of the door are two marked bricks, the first inscribed with the date "1771" and the second with two initials "WH", presumably referring to William Hopper, who owned Dockery's Lot at that time.

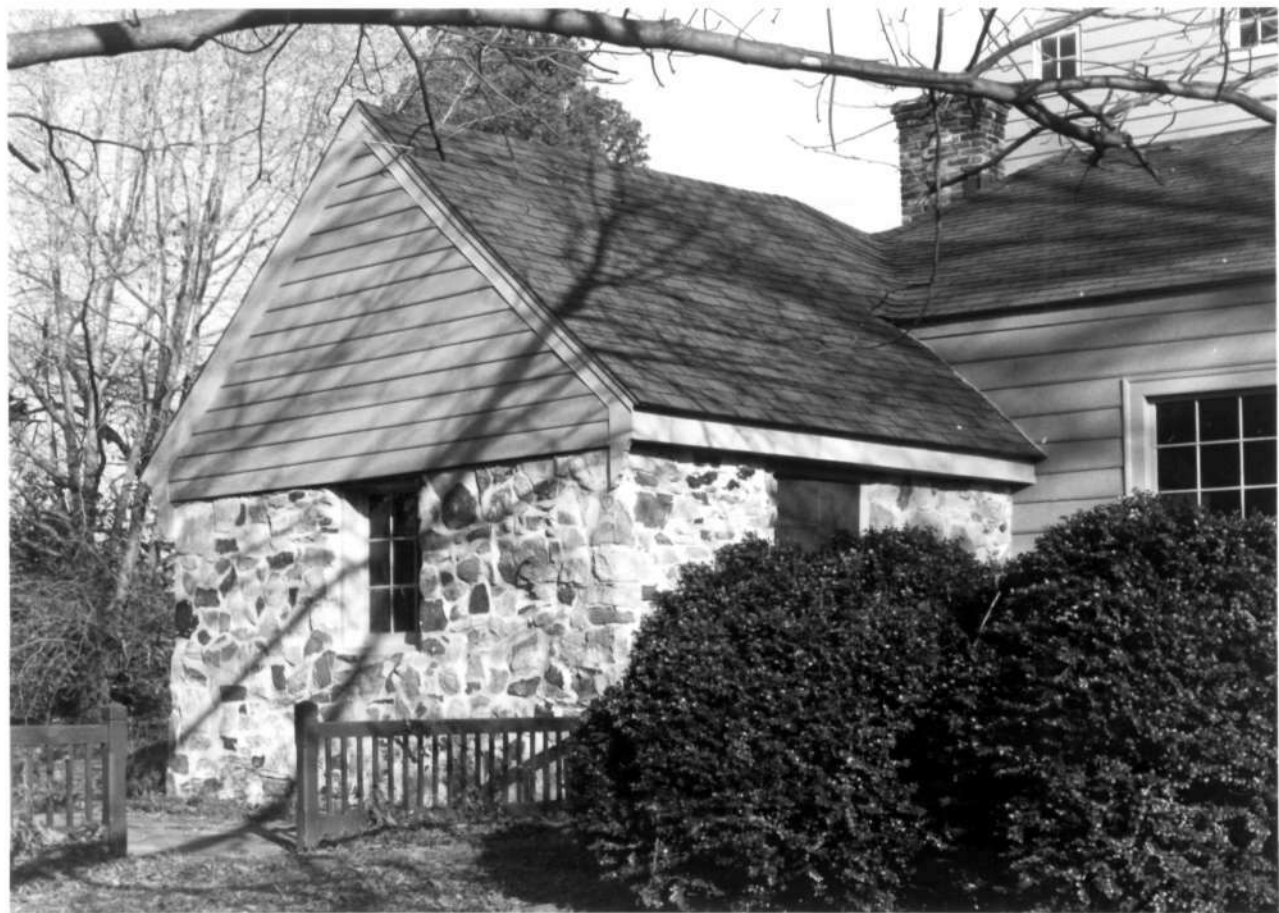
QA-196 Wharf House - stone meat house, before 1798
(Franklin House)
OR V 1978.

This building adjoins a modern frame addition to the southwest of the main house. It is of stone construction and can be positively dated to the 13th century as it is listed and described on the 1798 Federal Direct Tax. It is almost square, 13 feet by 14 feet, with a gable roof. The door is located in the center of the southeast facade, and there is a large nine light window (not original) in the center of the southwest gable. A wood lintel remains embedded in the center of the rear wall, suggesting that there may once have been a window in that facade as well. The roof is constructed of rafter pairs with two sets of collars resting on a flat false plate supported

by heavy joists. All framing members are hewn and pit sawn, and the rafters are secured at the ridge with a pegged mortise and tenon joint. The collars are half-lapped into the rafters, and the gable studs are secured with wrought nails. One gable is sheathed on the inside with one-inch boards secured with wrought nails.
